# CASAR<sup>®</sup>

## SPECIAL WIRE ROPES

# The Inspection of Steel Wire Ropes

by Dipl.- Ing. Roland Verreet

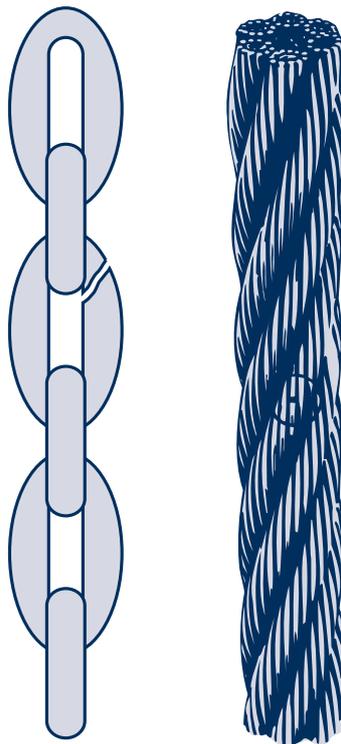
Fig.1: The failure of one element

With a chain, which represents a series connection of load bearing elements, the failure of a single element results in the total failure of the whole lifting device. In contrast to this, the load bearing elements of a wire rope are in a parallel arrangement. Therefore, even after a many wire breaks, a steel wire rope can still be operated safely (Fig. 1).

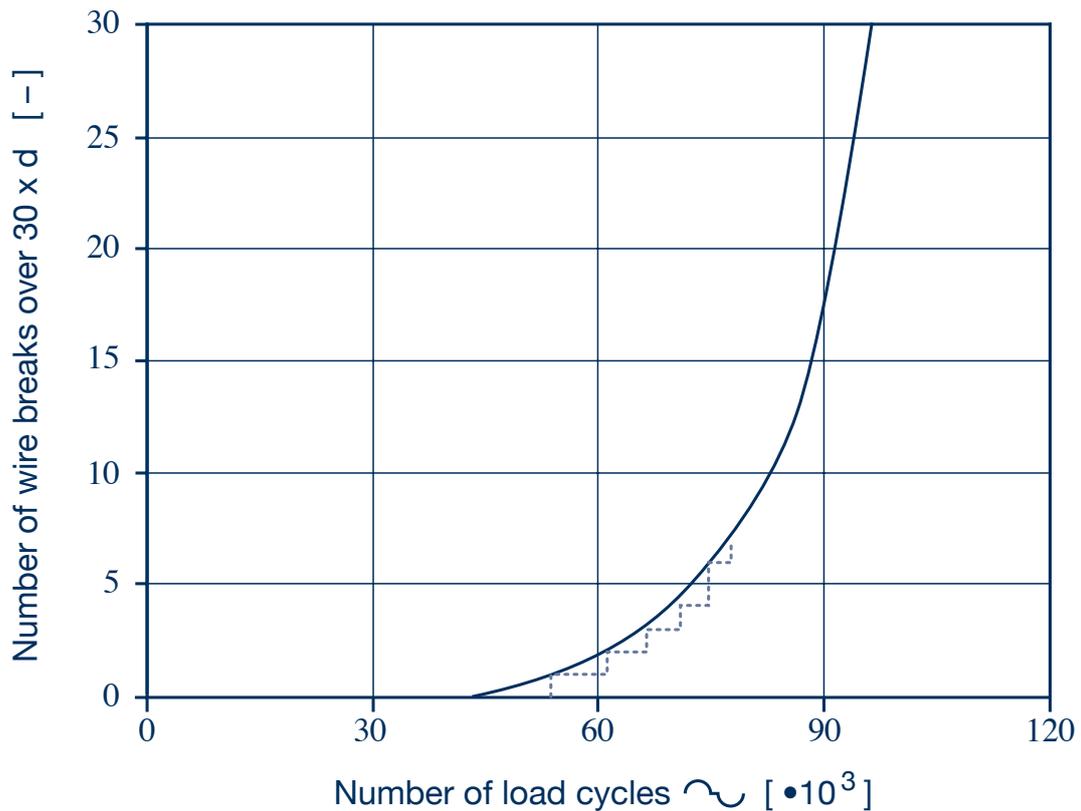
Fig. 2: Typical development of wire breaks in a steel wire rope

As a rule the number of wire breaks will increase steadily. Fig. 2 illustrates the typical development of wire breaks with an increasing number of cycles. Monitoring this natural course of increase is one of the objectives of wire rope inspection in order to

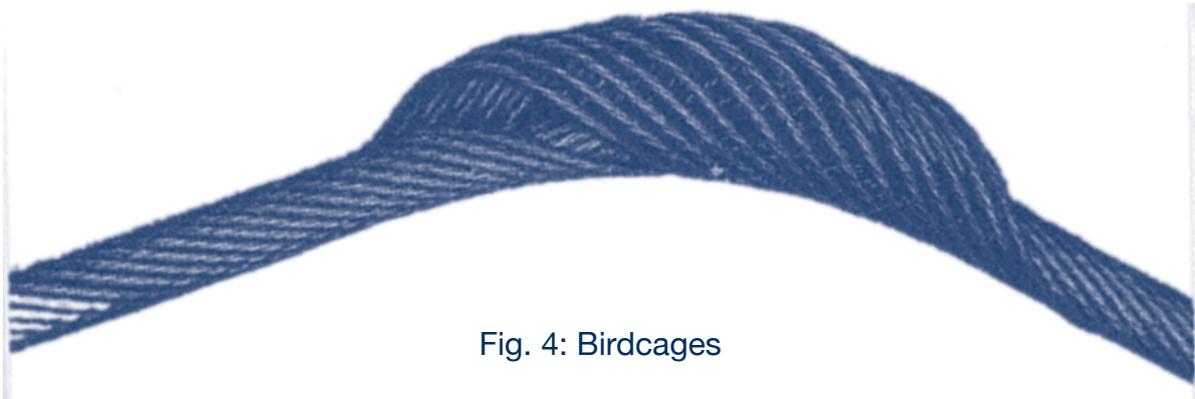
Fig. 4: Birdcages

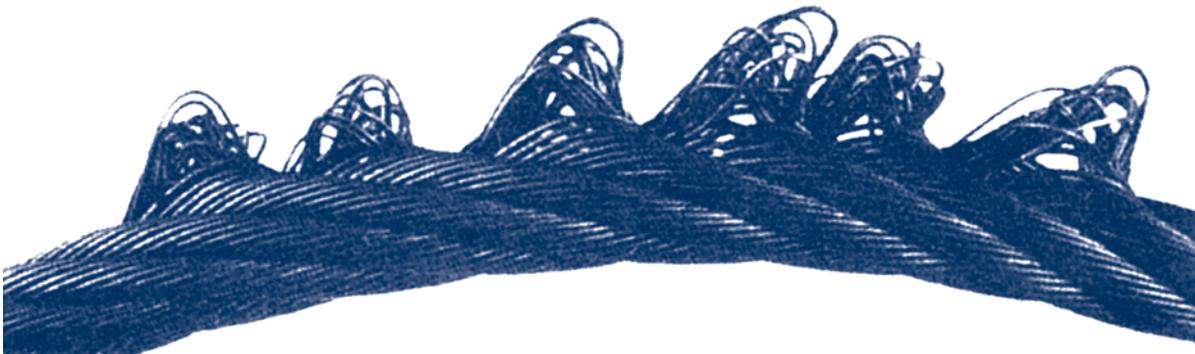
Fig. 5: Wire loops

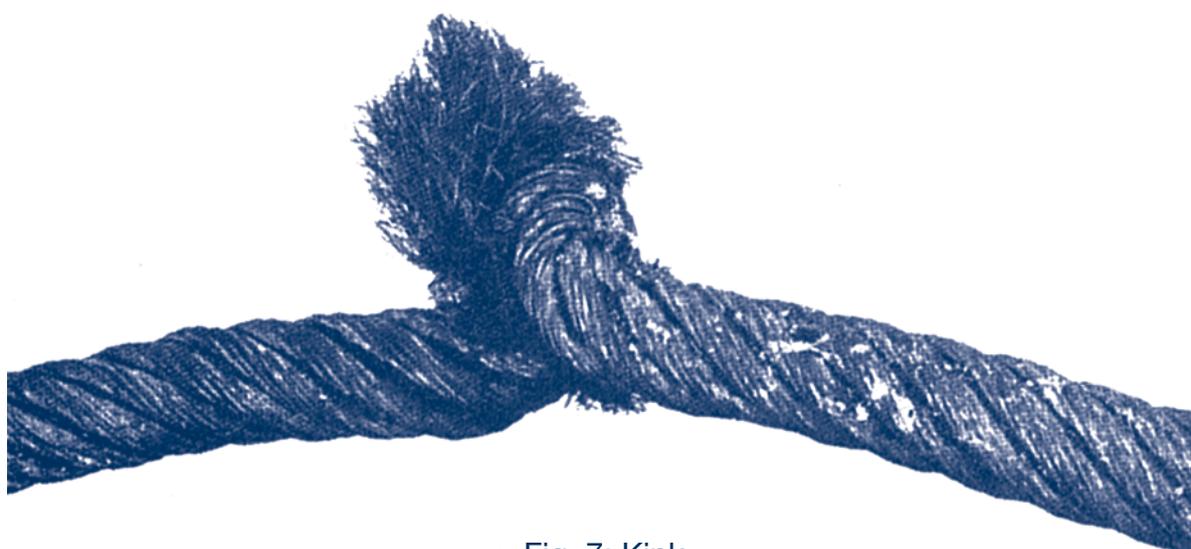
Fig. 7: Kink

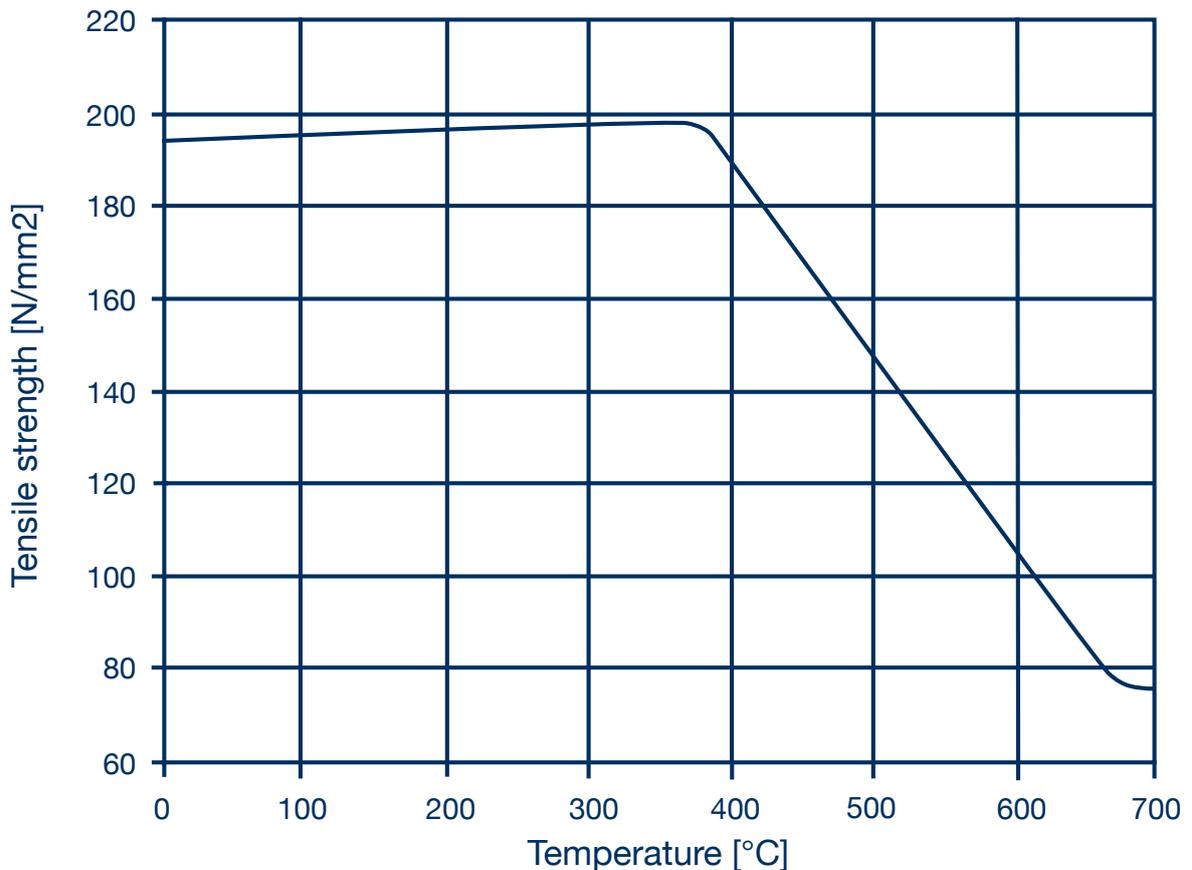
Fig. 8: The effect of temperature on the tensile strength of the wire

g) Rope zones exposed to aggressive agents or heat. Chemicals or heat can considerably reduce the breaking strength of wire ropes. Long-term temperatures of about 200 degrees Celsius do not pose a risk for the wire material (Fig. 8). However, temperatures of only 50 degrees Celsius can result in the complete loss of the rope lubricant and consequently in a noticeable deterioration of the rope's working conditions.

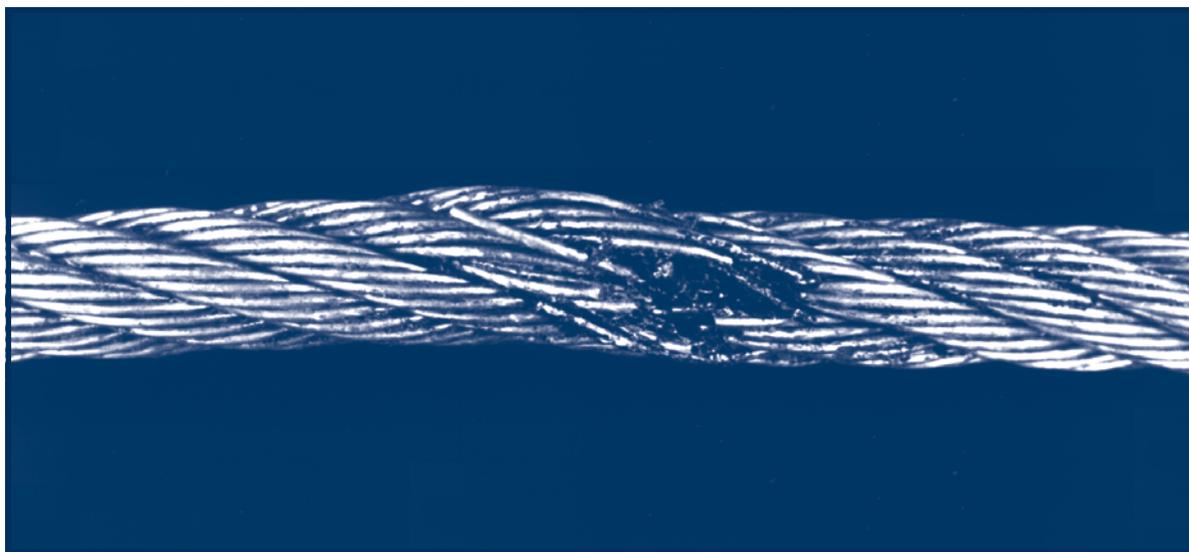
Fig. 10: The discard criteria for  $6 \times d$  has been reached.

Fig. 10 shows a rope which must be discarded because of local damage. Here the discard number of wire breaks for  $30 \times$  rope diameter has not been reached but the discard number for  $6 \times d$  has.

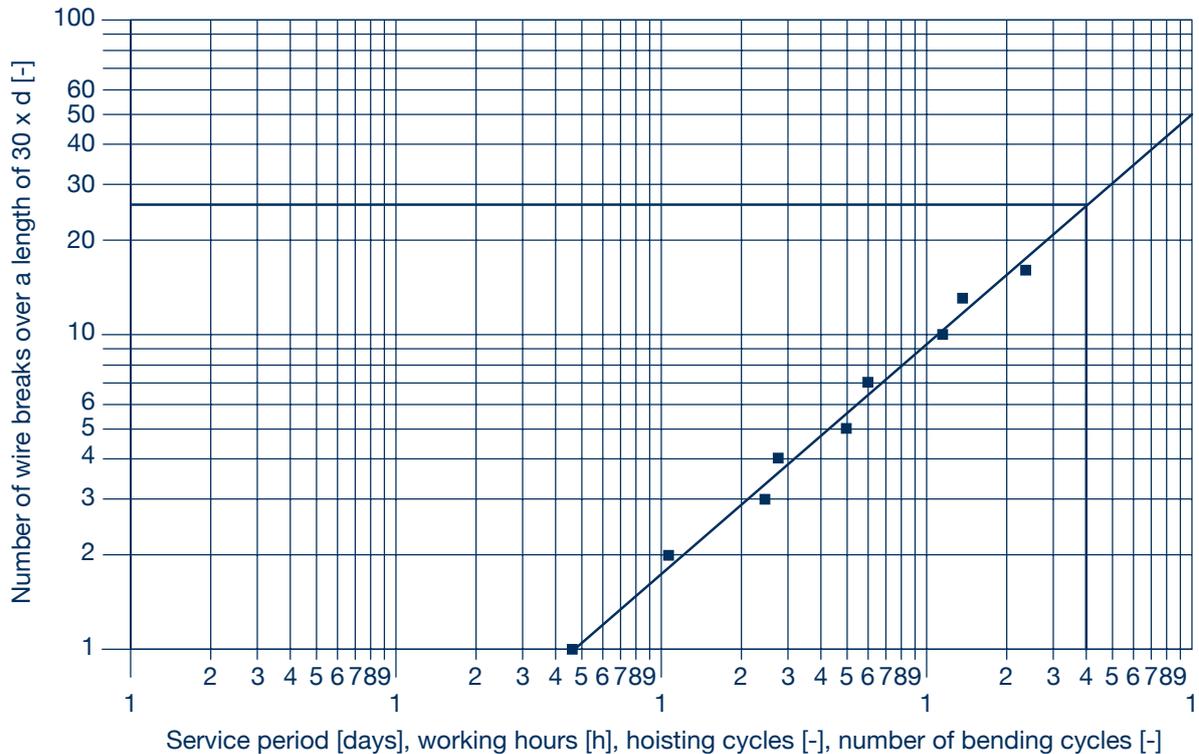
Fig. 12: Predicting the discard date or discard number of cycles

Fig. 12 illustrates a double-logarithmic graph with nine assessed values of wire breaks which were plotted against the corresponding number of bending cycles. The approximating straight line intersects the line indicating the discard number of wire breaks, 26, at a bending cycle number of 40,000. After about 25,000 bending cycles or an approximate 60 % of the service life the operator can predict the discard date of his wire rope with comparatively high certainty.

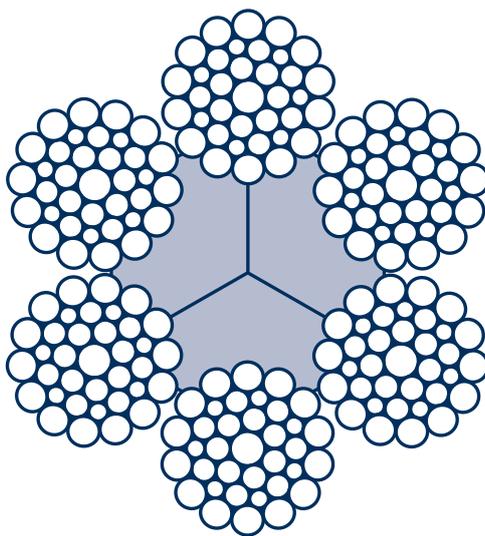
Fig. 13: 6 x 36 wire rope with a fibre core

According to DIN 3064, in a 6 x 36 wire rope design with a fibre core, the outer wires which are accessible to visual inspection have a share of almost exactly 50 % of the metallic cross-sectional area of the rope (Fig. 13). The other 50 % of the metallic cross-sectional area cannot be inspected visually.

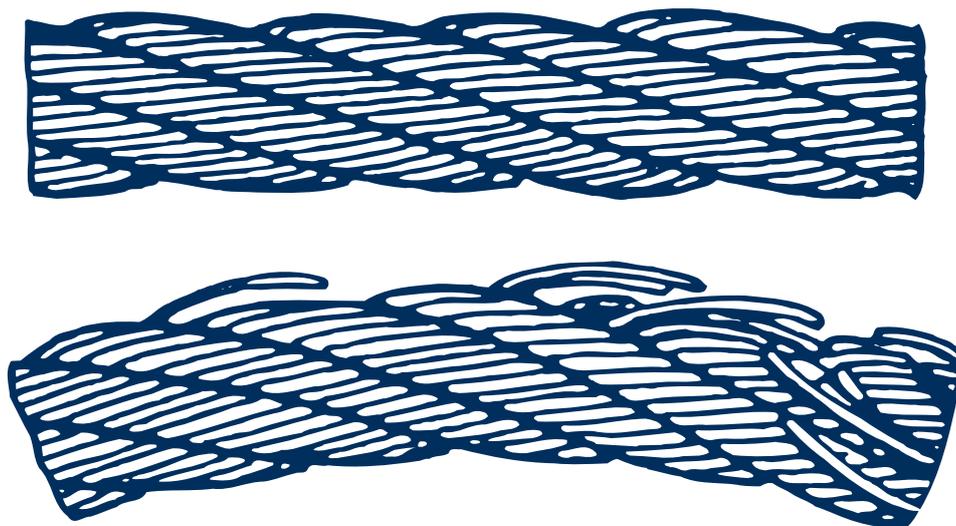
Fig. 14: Detecting wire breaks by bending the rope

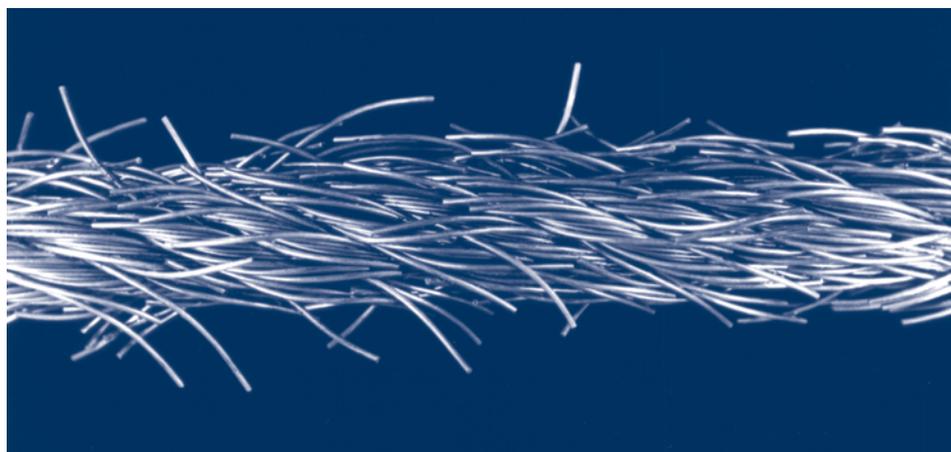
Fig. 15: Wire break ends made visible by bending the rope

In Fig. 15 a rope is shown which seemed to be free of wire breaks. However, unloading and subsequent bending of the rope brought to light the significant number of wire breaks which had developed at the underside of the strands where they contacted the steel core. The long free wire ends clearly indicate that the wire breaks did not occur at the rope's surface.

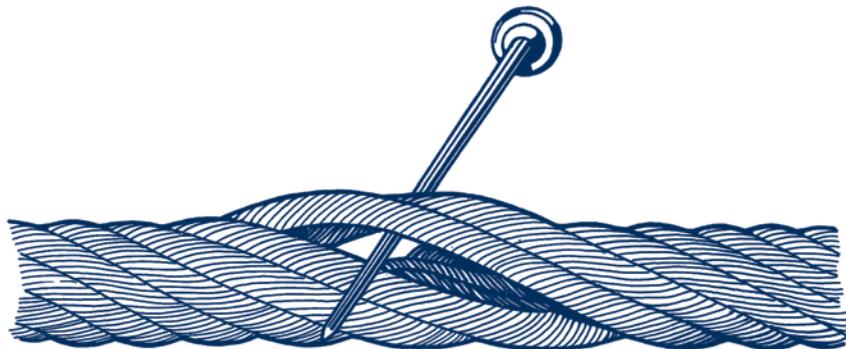
Fig. 16: Opening a wire rope with a Marlin spike

Some publications recommend to lift the outer strands of the rope with the help of Marlin spikes in order to assess the state of the steel core and the underside of the outer wires (Fig. 16).

As this procedure quite often causes damage to the rope construction in the zone inspected, it should be carried out by a rope expert only, if at all. A rope tightly closed cannot be opened with this method anyway. Casar wire ropes with internal plastic layers should not be opened up with a spike as this can cause permanent damage to the structure of the rope.

Lifting the top layer of strands forcefully with a screwdriver or a Marlin spike (Fig. 16), as is often practised to examine the condition of core rope, should be avoided. It happens often that the rope is irreparably damaged in this way, especially when there is moderate tension on the rope.

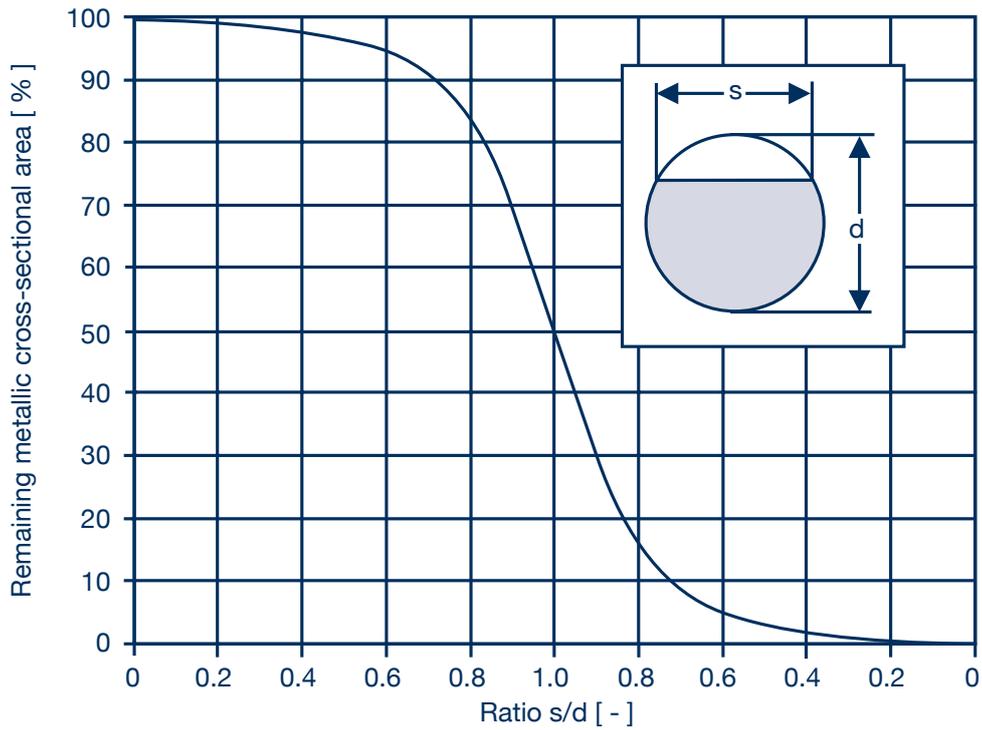
Fig. 17: Determining the remaining metallic cross-sectional area as a result of wear

To determine the effect of abrasion, the width of the wear ellipse on the wire surface is measured with a strong, measuring magnifying glass. From the ratio of ellipse width to wire diameter the loss of breaking strength of the single wire can be found by means of a pre-determined graph (Fig. 17). If broken wires can be removed from the rope construction, the height of the wire in the centre of the wear ellipse can be measured and the remaining cross-sectional area can also be determined (Fig. 18).

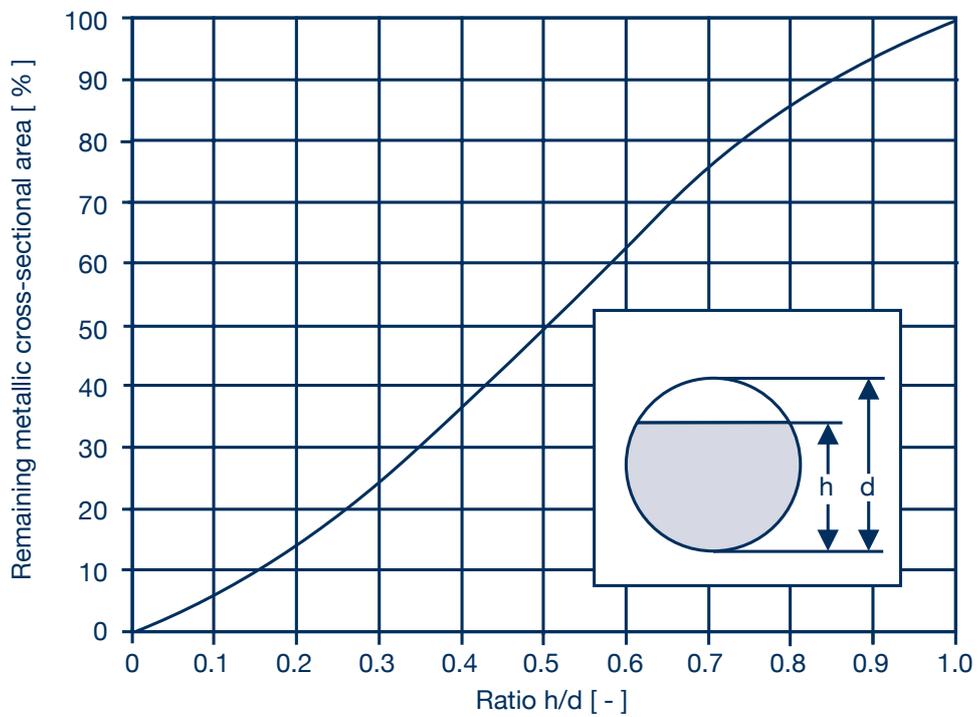
Fig.: 18: Determining the remaining metallic cross-sectional area as a result of wear

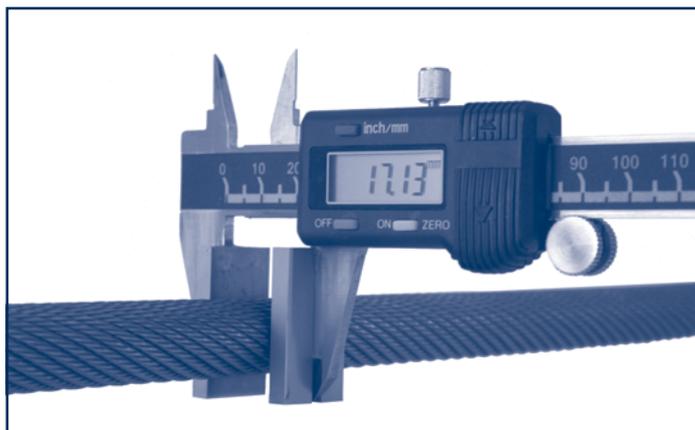
Fig. 19: Digital vernier calliper with wide jaws

Vernier callipers (Fig. 19) are used for the exact measurement of the rope diameter along various rope zones which are of particular interest in the condition assessment of the rope. If possible, the vernier callipers should be equipped with wide jaws. A digital display is also an advantage.

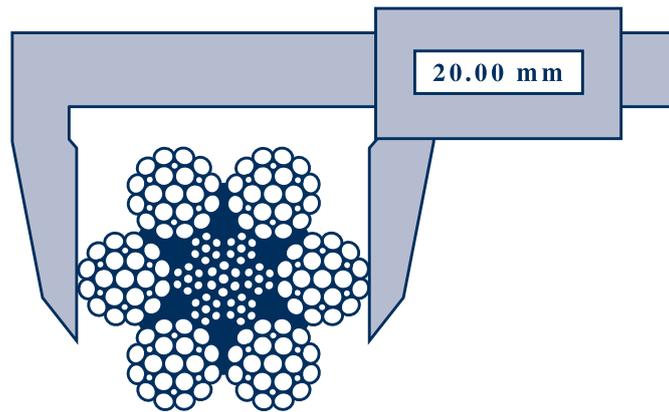
Fig. 20: Correct measurement of the rope diameter

Let us now look at the cross-section of a six-stranded wire rope: measuring the rope thickness over the crowns (Fig. 20) results in a higher value than measuring over

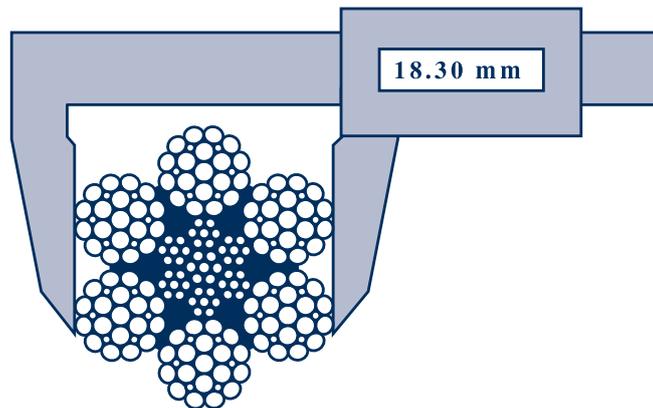
Fig. 21: Wrong measurement of the rope diameter

the valleys (Fig. 21). The diameter of the wire rope is defined as the diameter of the circumscribing circle.

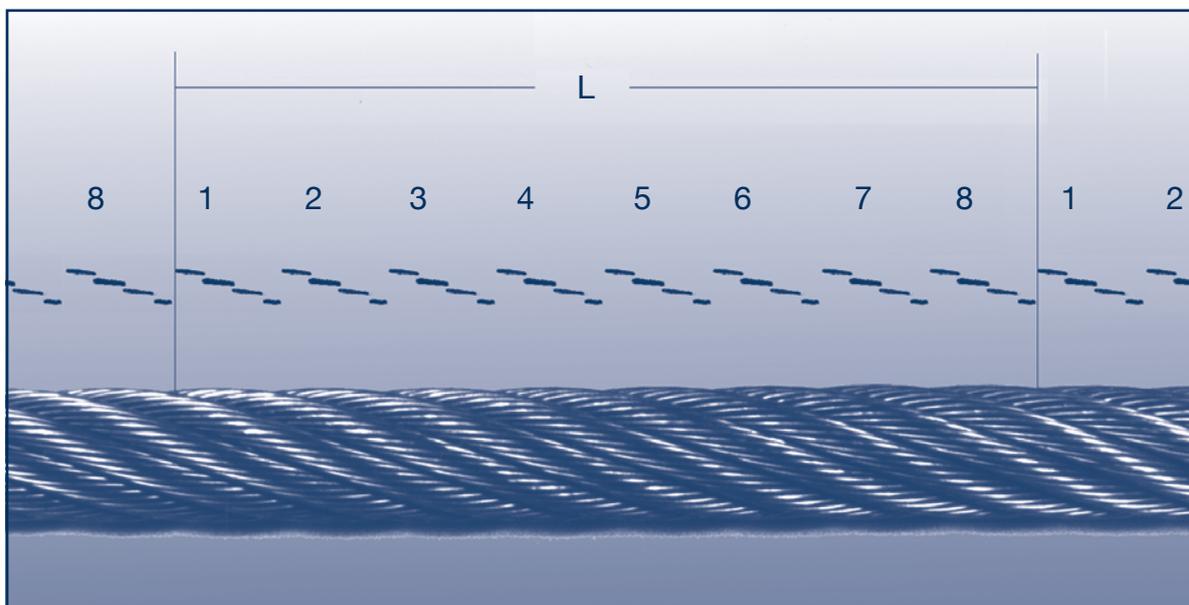
Fig. 23: Measuring the rope lay length

Another possibility to measuring the lay length - and at the same time create a document for the archives - is making a rubbing of the rope surface on a long strip of paper. This print is produced as follows: first the loose end of the wound-up strip is attached to the rope by means of sticky tape. Then the strip is unrolled along the rope length while a wax crayon is simultaneously drawn along the same zone. On the crowns of the strands you will get a clear print of the rope's outer wires. The paper strip is then labelled for later analysis (Fig. 23).

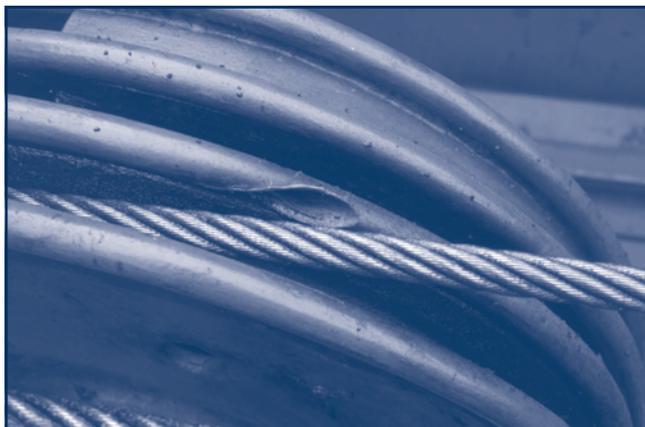
Fig. 24: Indications of abrasion on a structural component

Indications of abrasion on a structural components (e.g. on a crane) may give valuable hints as to why the reeving system is not working perfectly (Fig. 24). These could also explain why abnormal damage to the rope has occurred.

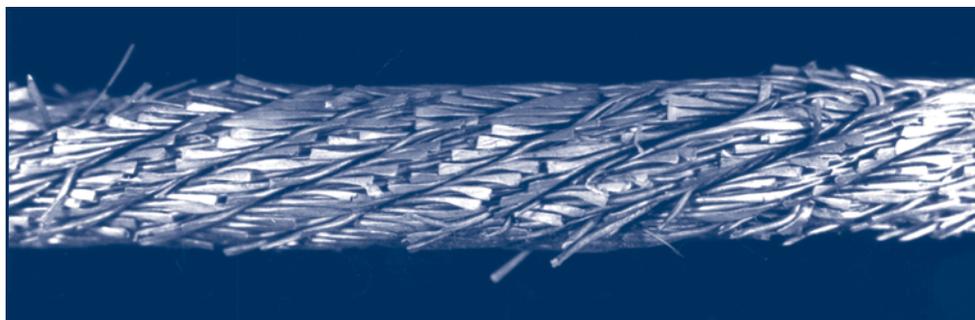
Fig. 25: Wire rope damage from a too tight sheave groove

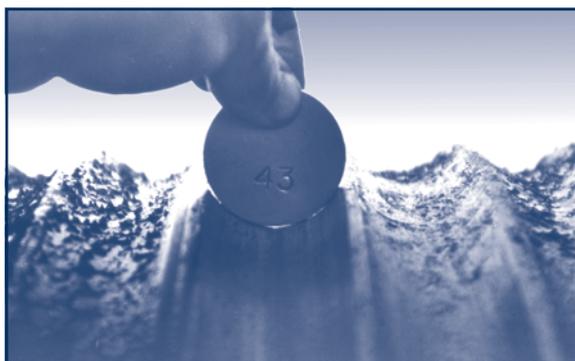
Fig. 26: Groove gauge of the right size

For checking the groove diameter, one would insert the correct size groove gauge into the sheave groove and also examine the conditions of the contact area (i.e. the quality of the surface finish). If the gauge fits well into the groove's circumference then the groove dimensions are correct (Fig. 26). If the gauge touches the sides of the groove only, the groove is too narrow (Fig. 27). If it lies on a small part of the circumference only, the groove is too wide. In both cases additional gauges must be used to find out the extent of the deviation from the desired value.

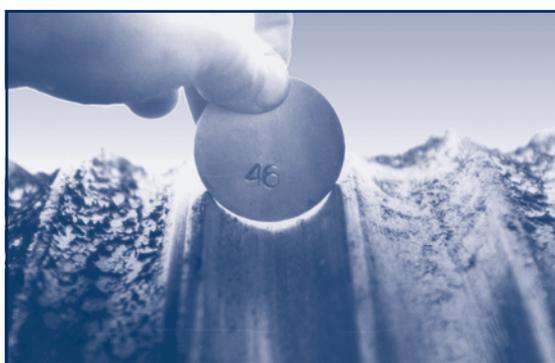
Fig. 27: Groove gauge bigger than the groove

Inspection is often made difficult by the cramped conditions of many installations. If it is not possible to check the contact area of the groove gauges from the sides, it is then possible to pull the gauge through the groove and then assess the contact conditions on the basis of the sliding tracks in the rope lubricant. A narrow track in the centre indicates that the groove is bigger than the gauge. A wide track in the whole groove bottom means that the groove and the gauge are of equal size. Two narrow tracks on the flanges suggest that the gauge is bigger than the groove.

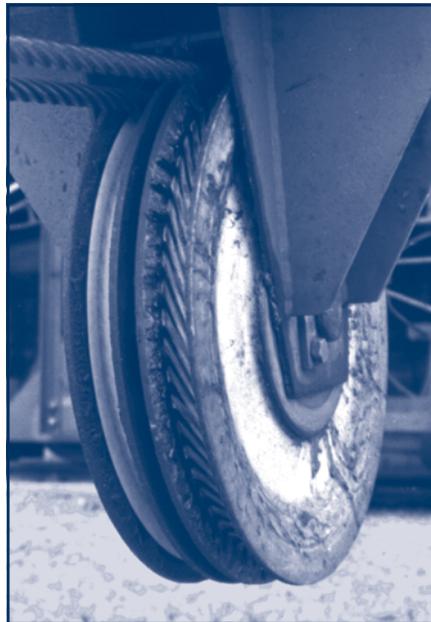
Fig. 28: Indentations in a sheave groove

rope's service life considerably. If negative imprints of the rope can be found in the groove bottom (Fig. 28), these may provide optimal contact areas for the current rope but as soon as the rope is changed the new rope will not fit into this pattern of negative imprints and will be destroyed quickly. Sheaves with severe imprints must be changed together with the rope. Alternatively, if remachining of the groove is possible, this must be done before the rope is changed.

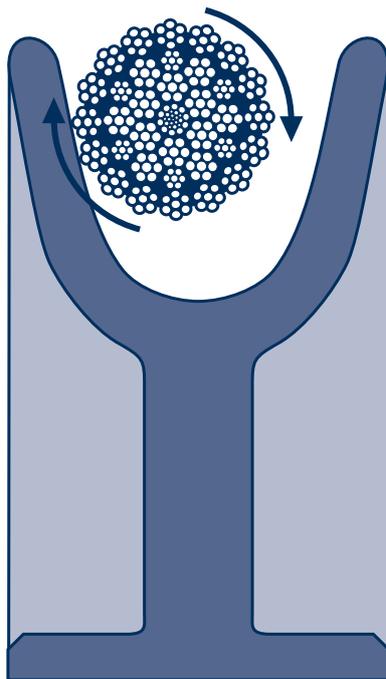
Fig. 29: The rope rolls into the groove bottom

The reason why the rope first contacts the sheave flanges is because the fleeting angle which the rope makes with the sheave is greater than the recommended value. DIN 15 020 recommends a maximum fleeting angle of  $4^\circ$  for non-rotation-resistant ropes and  $1.5^\circ$  for rotation-resistant (non-spin) ropes.  $4^\circ$  is equivalent to a deflection of about 1 m over 14.3 m, and  $1.5^\circ$  is equivalent to a deflection of 1 m over 38.2 m.

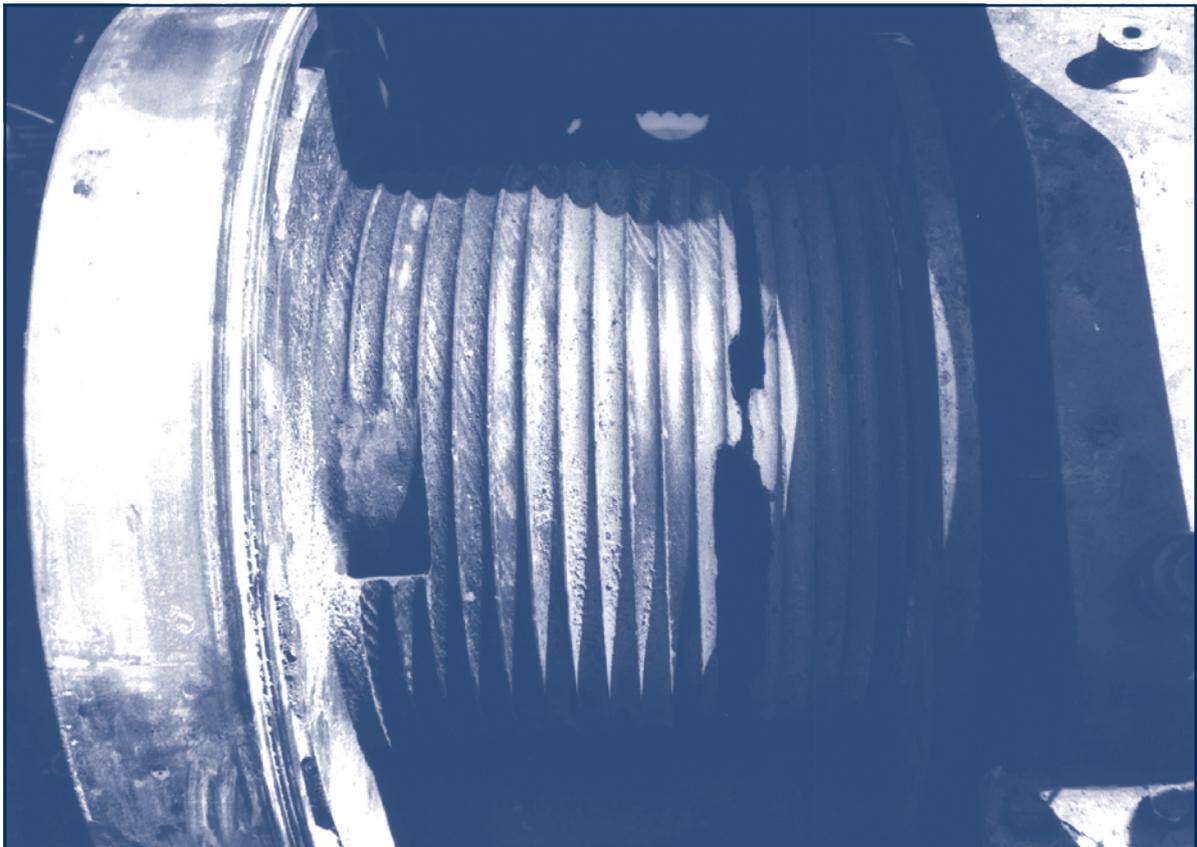
Fig. 30: A drum severely worn at the loading point

Fig. 30 shows the drum of a dragline on which two parallel ropes are wound with a double pitch arrangement. In the zone of the loading point, the drum has virtually been cut in two by the two wire ropes. Newly installed ropes on this drum would experience extremely bad operating conditions and would definitely fail prematurely.

In order to avoid such concentrated stresses on a drum, the loading point should be shifted at regular intervals during the rope's service life. If this is not possible, one can also slightly alter the rope length after certain periods of operation so that the loading point on the drum is shifted.

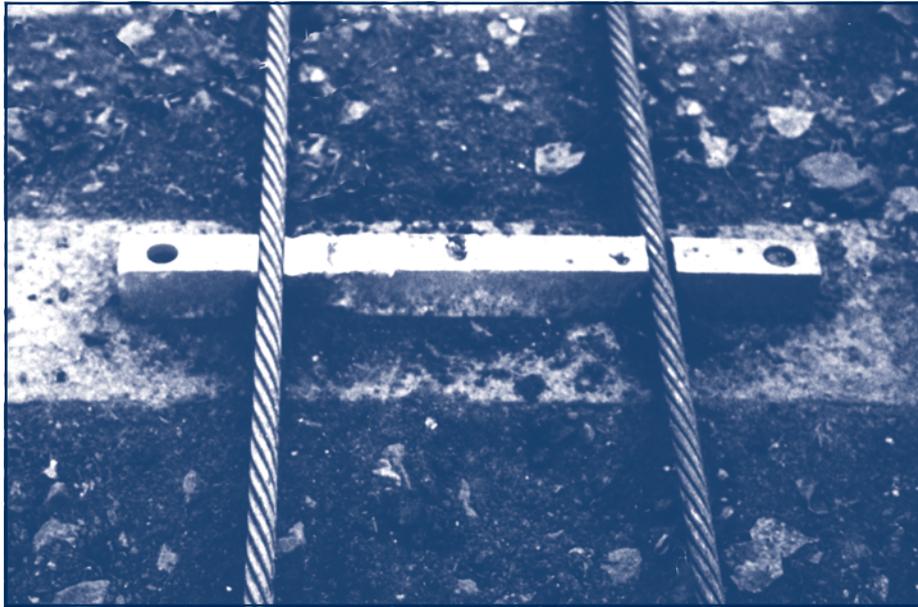
Fig. 31: Heavily worn rope support bars

Horizontal running ropes will always show a certain degree of sagging. In order to avoid abrasion on structural members (e.g. of a crane) or on the ground, wooden boards or plastic sheets are often installed. They should also be examined carefully during an inspection. If these supports are heavily worn (Fig. 31) there is a danger that a new, slightly thicker rope gets stuck in the grooves, is damaged or even breaks.

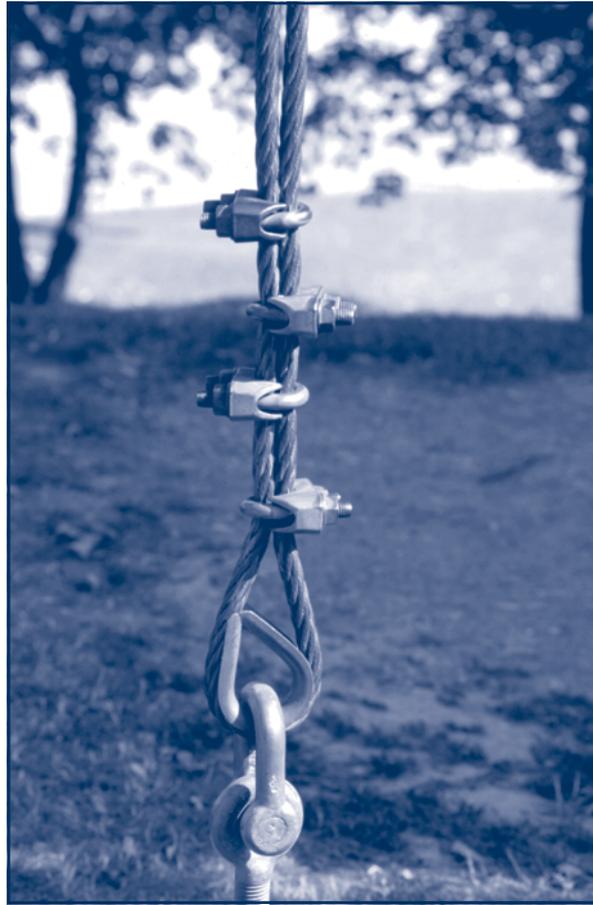
Fig. 32: Rope clamps attached incorrectly

Fig. 32 clearly illustrates the operator's insecurity. Since he did not know which line to put the saddle on, the clamps were fitted alternately right and wrong. The twisted thimble indicates that the rope has slipped within the clamps.

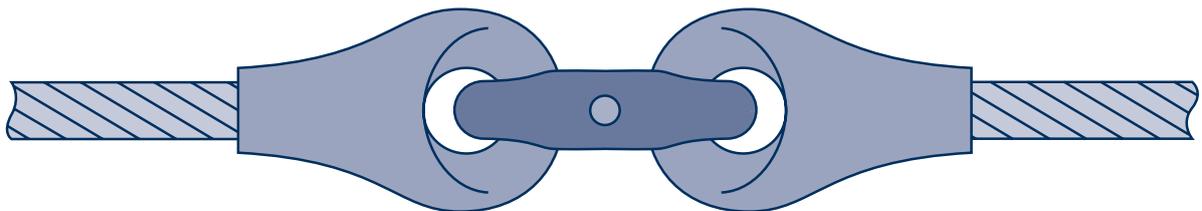
Fig. 33: Pear-shaped sockets with connecting link

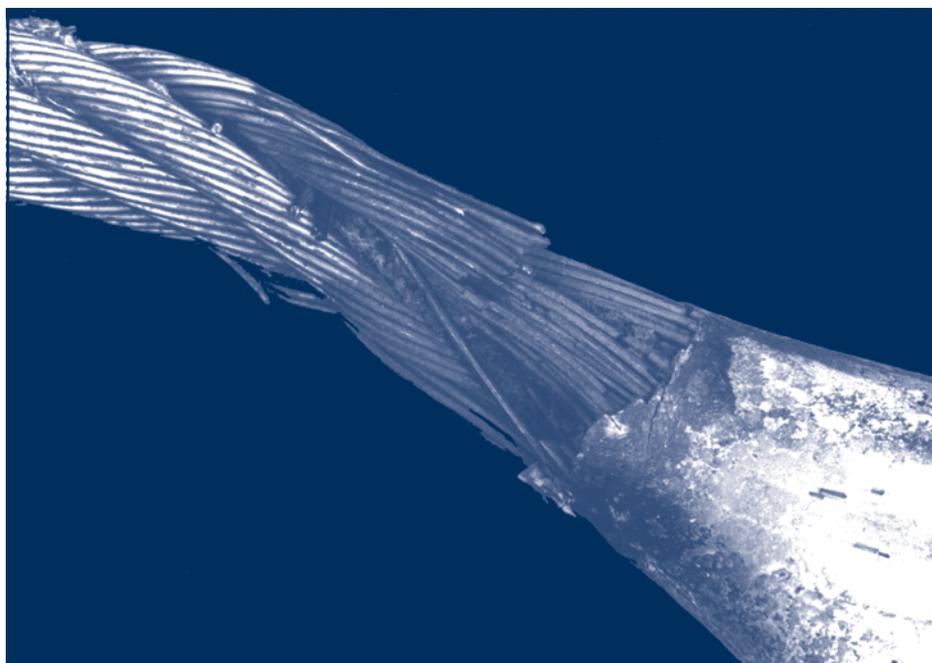
Fig. 34: Damage to a wire rope at the exit point of a pear-shaped spelter socket

With spelter sockets the rope zone adjacent to the throat of the socket is particularly at risk because it may have been treated with acid during the fitting of the end connection in order to roughen the wire surfaces. In the event that this zone was not carefully impregnated with a lubricant afterwards, severe and frequent corrosion is to be expected there.

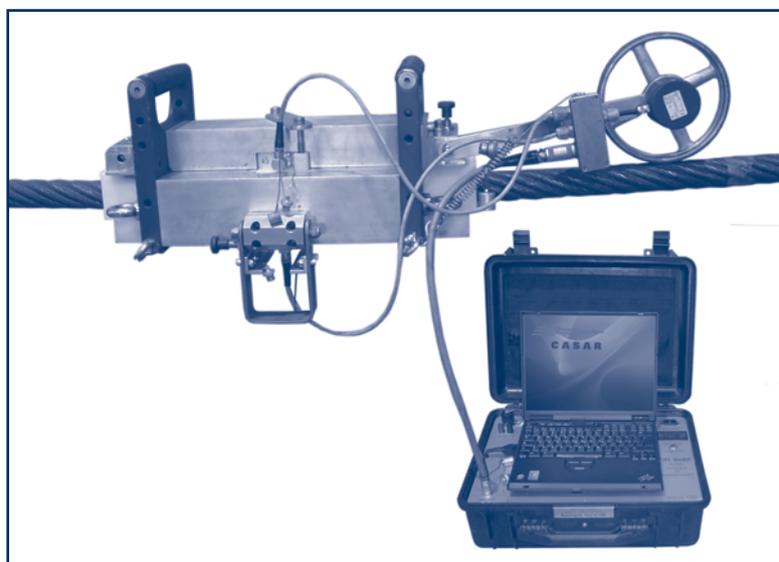
Fig. 35: Wire rope NDT instrument

NDT instruments are currently being developed which do not only record the data of rope measurements but also - by means of sophisticated computer algorithms - process the data with regard to the amplitude and frequency of the magnetic flux signals and inform the inspector about the extent of the rope deterioration. This aids considerably in the overall condition assessment of wires ropes, particularly in safety critical applications. Casar, in collaboration with the University of Stuttgart have developed and market a range of advanced wire rope NDT machines. The CMRT (Casar Magnetic Rope Tester) is offered in three sizes. The smallest machine, the CMRT 16, tests ropes with a diameter of 4 mm to 16 mm and a maximum metallic cross-section of 130 mm<sup>2</sup>. With the CMRT 40 ropes with a diameter of 16 mm to 45 mm and a metallic cross-section of max. 1000 mm<sup>2</sup> can be tested. The diameter for testing with the CMRT 60 is from 35 mm to 60 mm with metallic cross-section of up to 2400 mm<sup>2</sup>.

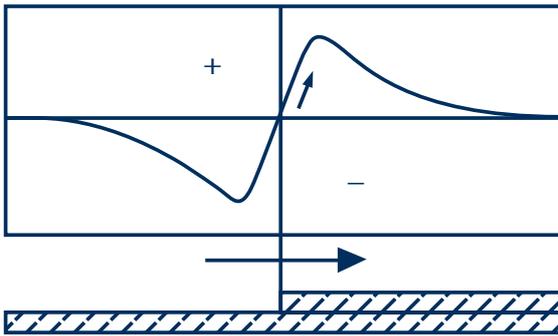
Fig. 36: Beginning of a wire

The calibration of the test instrument must be carried out with the greatest care. It is common practice to fix pieces of wire to the first few meters of the rope being inspected. These pieces of wire would match the diameters of the thickest and thinnest wires of the particular rope construction. They are attached by means of sticky tape in the valleys between the outer strands. In this way the inspectors can obtain reference values along the first centimetres of their recording which indicate the extent of the signal deflection for broken wires of these diameters.

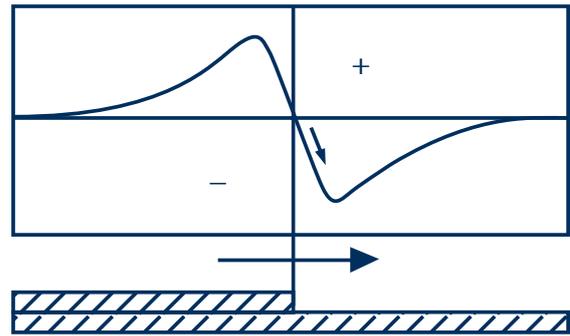
Fig. 37: End of a wire

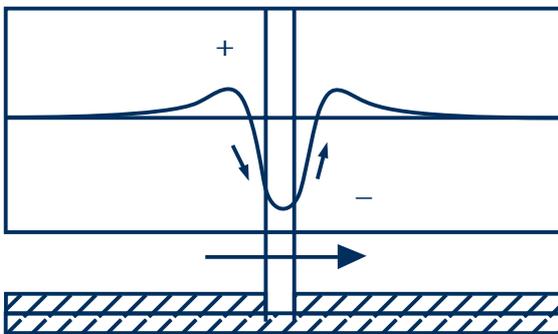
Fig. 38: Wire break

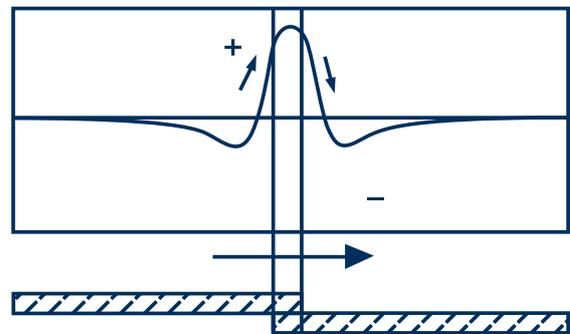
Fig. 39: Overlapping wires

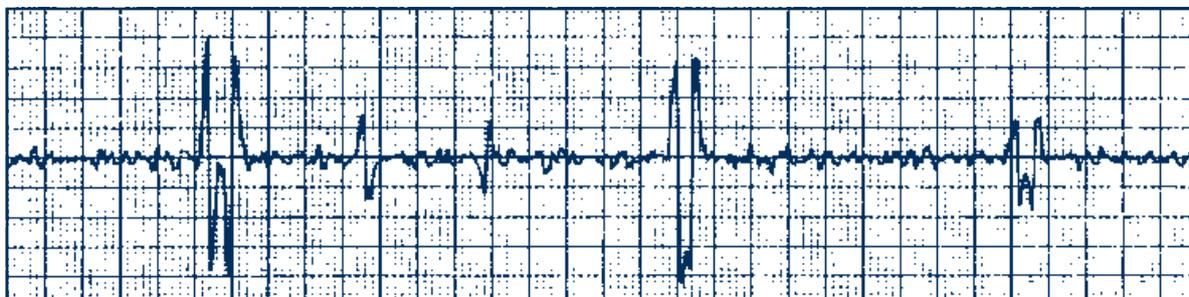
Fig. 40: NDT recording with wire breaks

The following two examples are meant to illustrate the problems when interpreting the measured NDT signals:

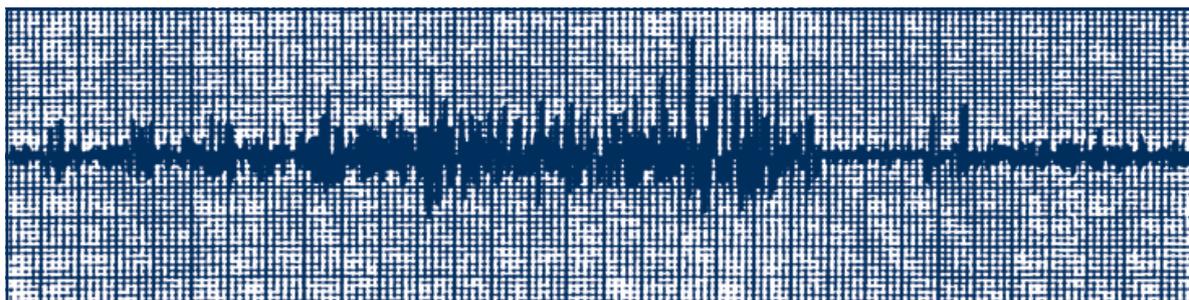
Fig. 41: NDT recording of a corroded rope zone

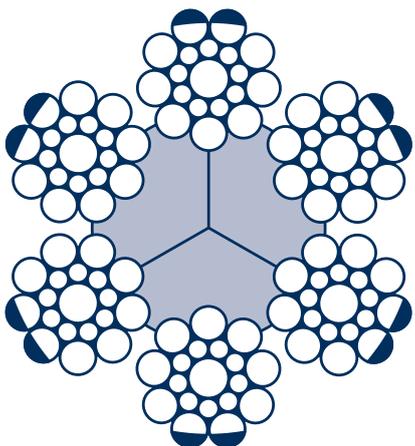
Fig. 42: 6 x 19 Seale rope with a fibre core, apparent loss of metallic cross-sectional area

For every cross-sectional view of the rope, the magnetic test instrument measures the loss of metallic cross-sectional area of the outer wires which are on the outside of the rope at that particular point. This corresponds, for example, to a loss of metallic cross-sectional area of 6 % (see sections marked black in Fig. 42). However, due to the weakening of all 54 wires instead of only 12 wires (see sections marked black in Fig. 43) the effective loss of breaking strength (i.e. cross-sectional area) amounts to nearly 30 %.

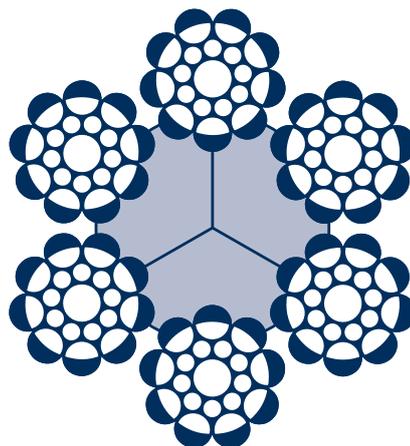
Fig. 43: 6 x 19 Seale rope, effective loss of metallic cross-sectional area

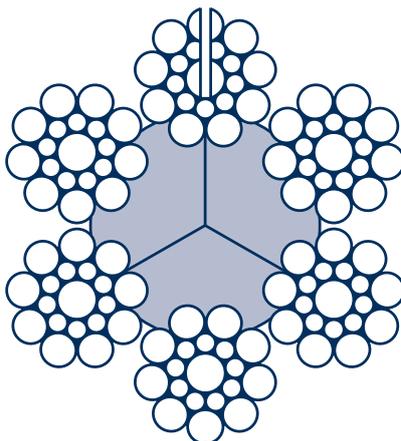
Fig. 44: 6 x 19 rope with a fibre core with a slot cut in one outer strand

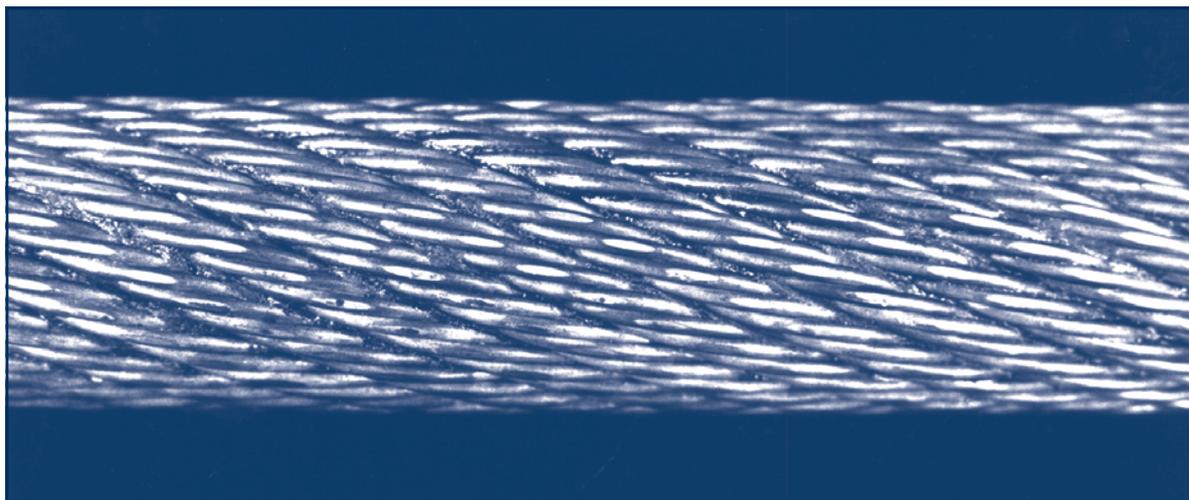
Fig. 45: The external condition of the crane rope (3rd layer)

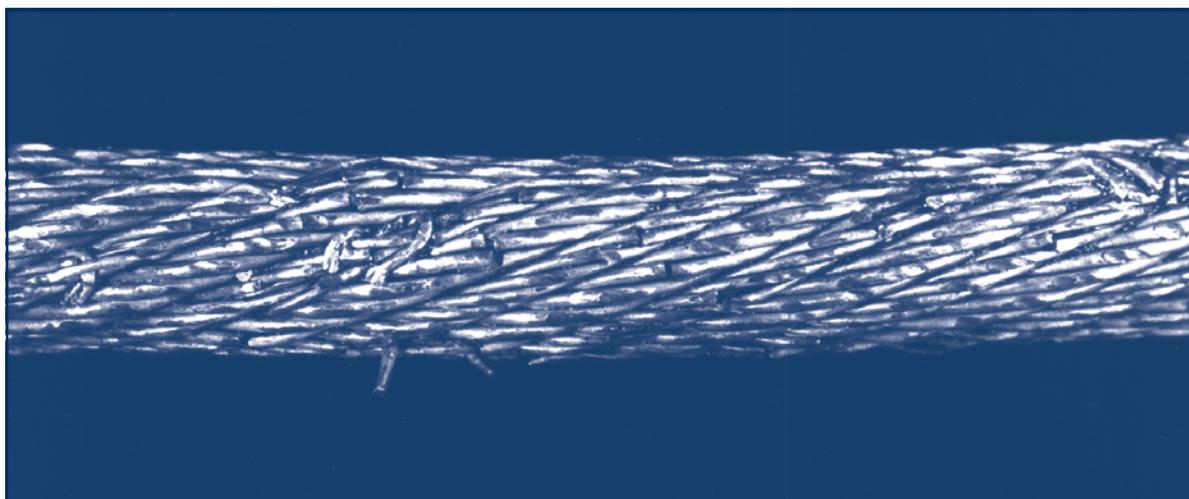
Fig. 46: The internal condition (2nd layer)

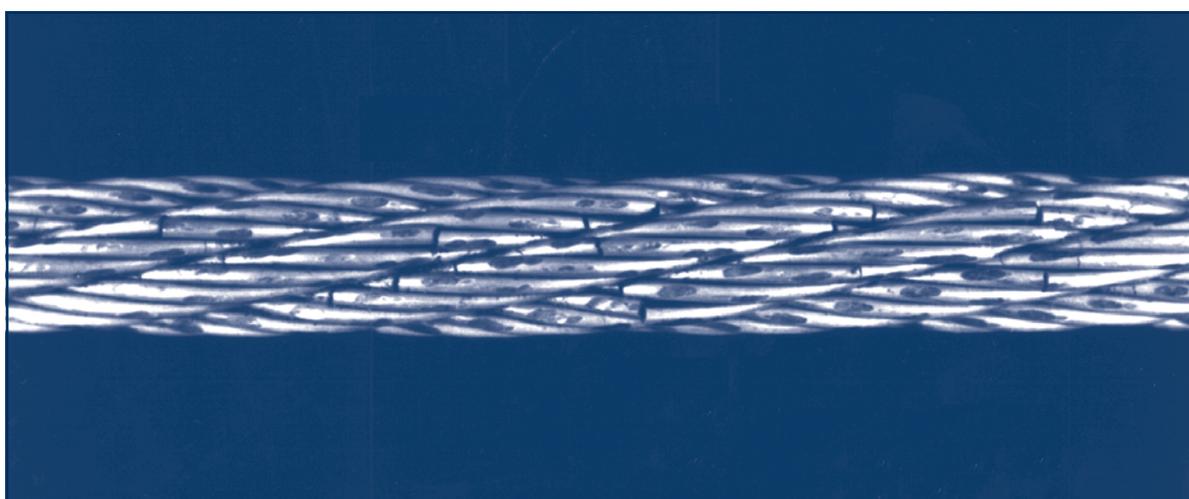
Fig. 47: The internal condition (1st layer)

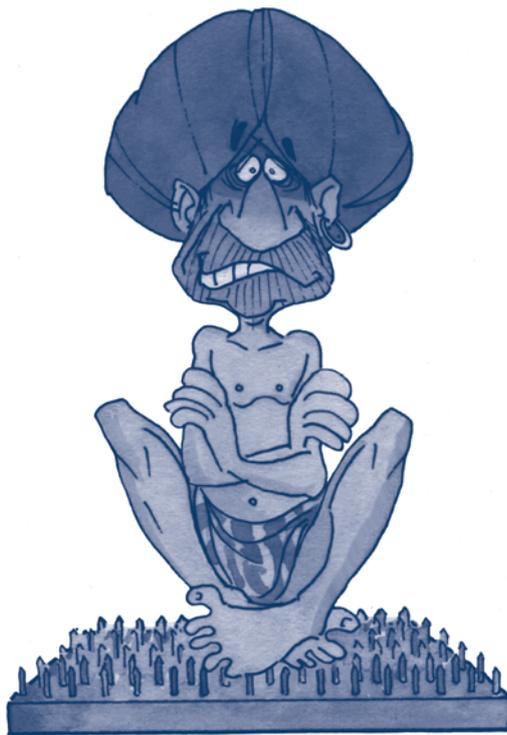
Fig. 48: Contact conditions for a conventional design of the steel core of a rotation resistant rope
