# CASAR<sup>®</sup>

## SPECIAL WIRE ROPES

# The Inspection of Steel Wire Ropes

by Dipl.- Ing. Roland Verreet

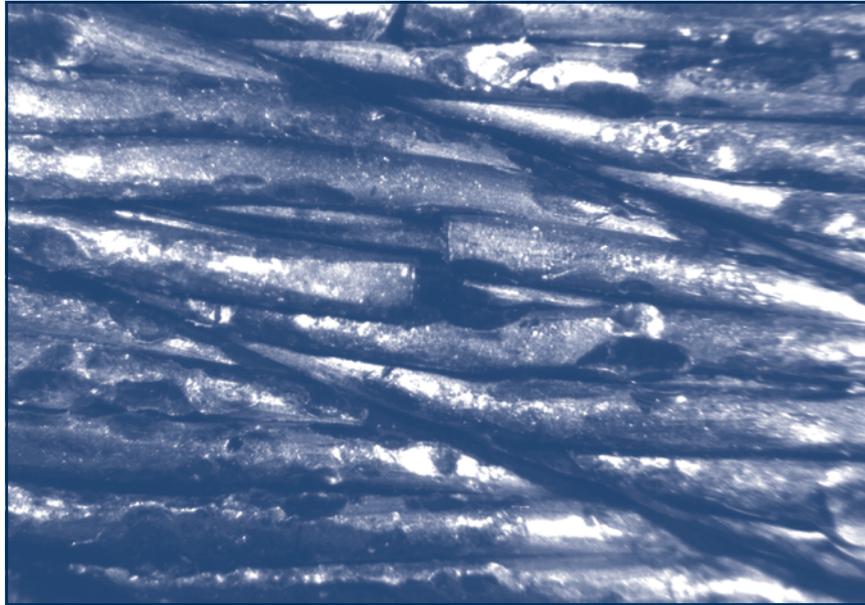
Fig. 50: Damaged wire rope surface

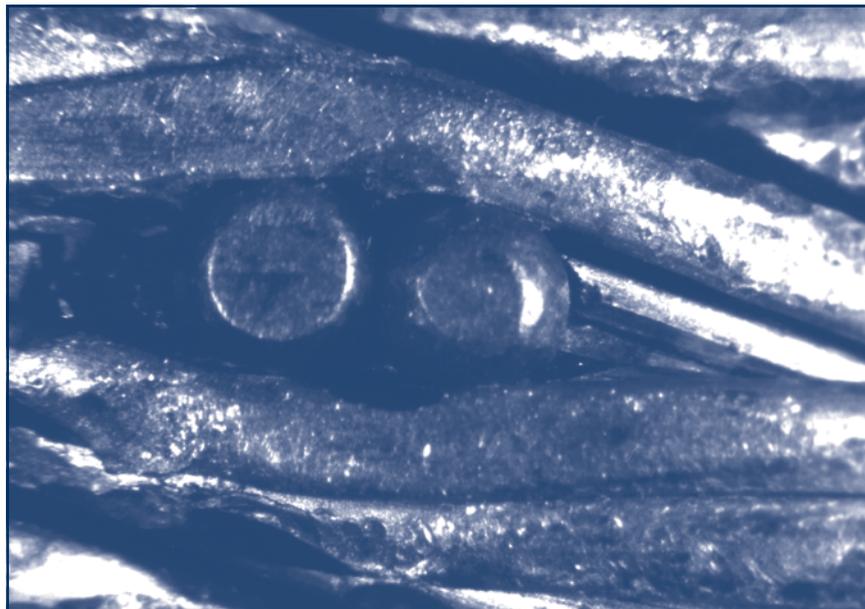
Fig. 51: Steel balls between the rope wires

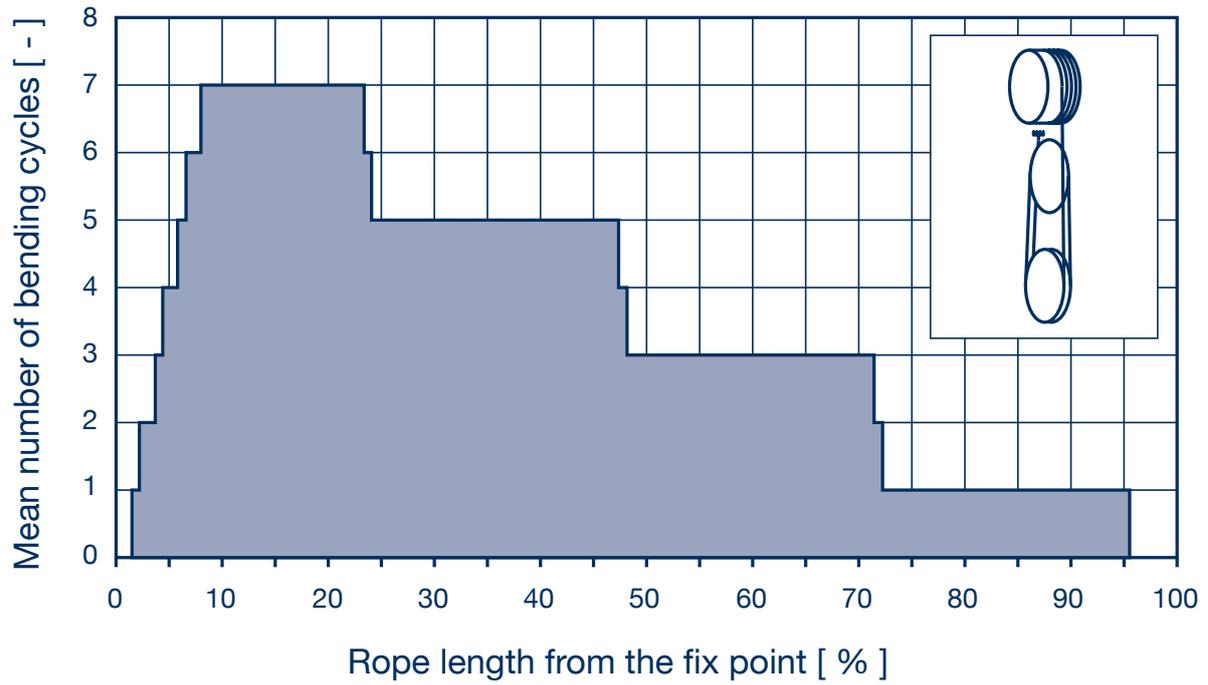
Fig. 52: Mean distribution of bending cycles for four times the same lifting action

The case is quite different for reeving systems which travel to different points with every lifting action. The distribution of bending cycles may then assume the shape as shown in Fig. 53. The most heavily loaded rope zone can in many cases not be determined.

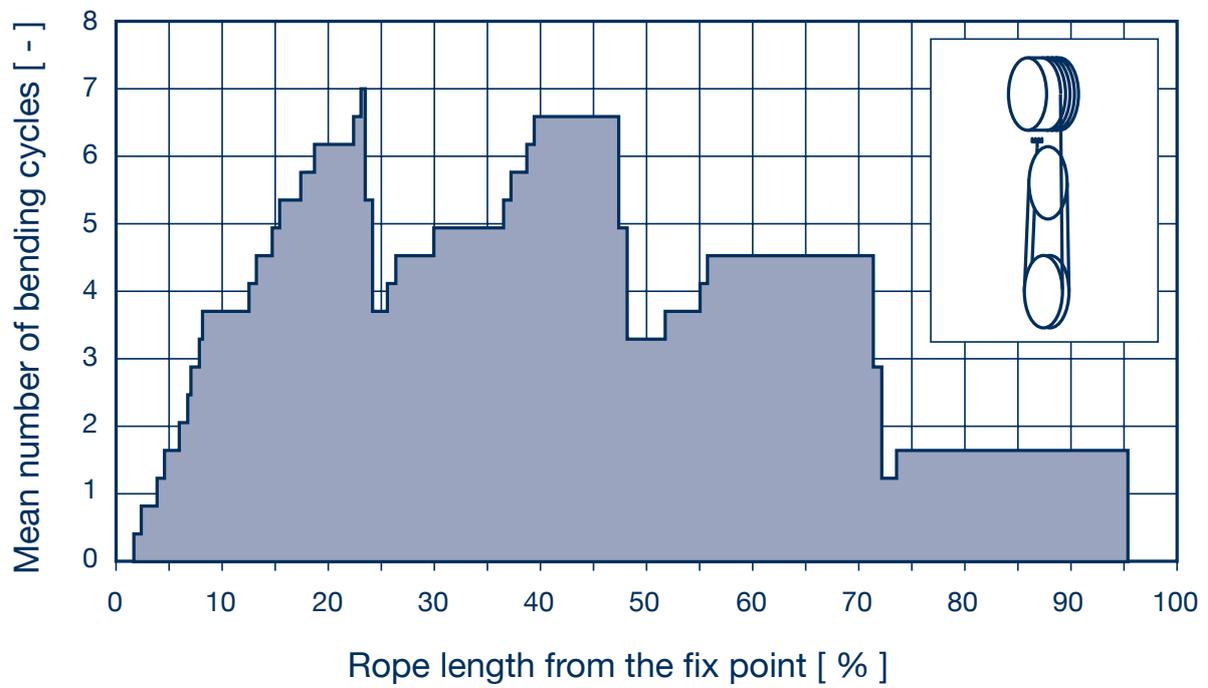
Fig. 53: Mean distribution of bending cycles for four different lifting actions

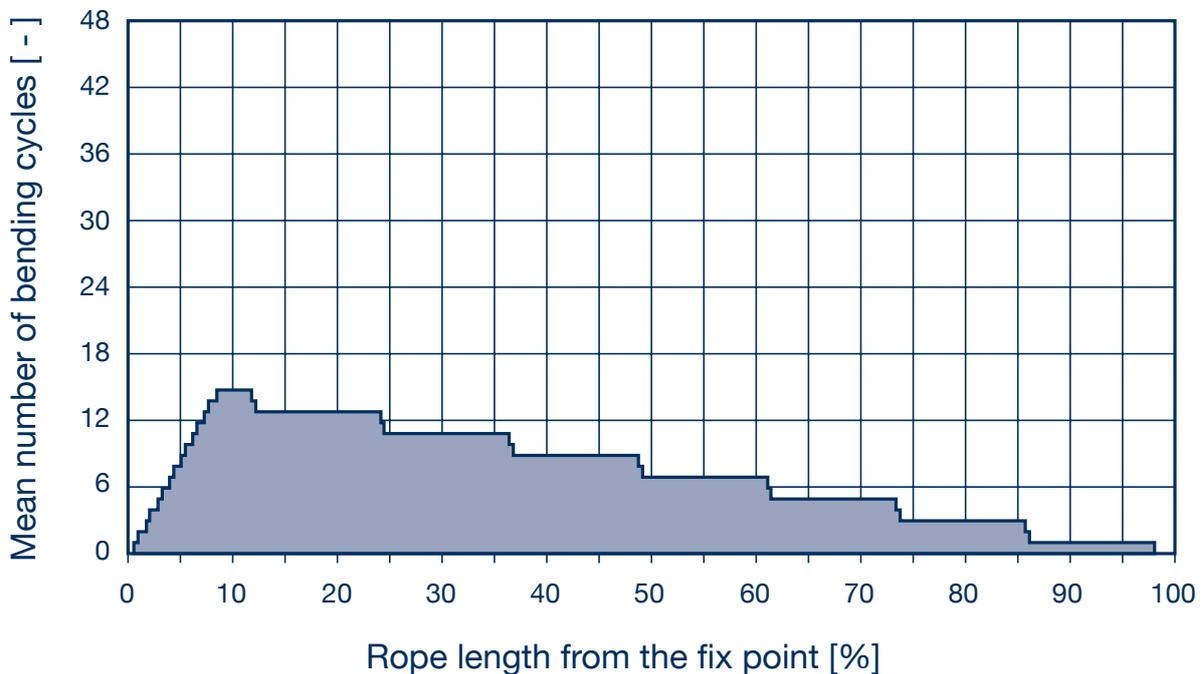
Fig. 54: Distribution of rope damage for a crane with an 8-fall reeving system

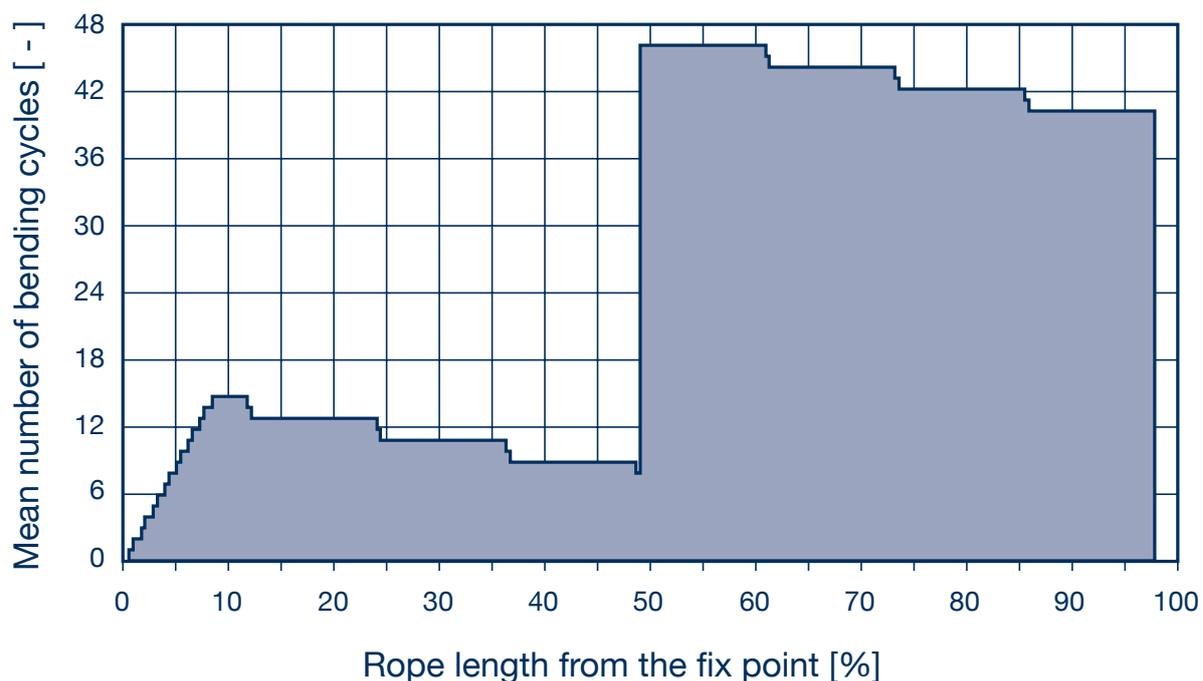
Fig. 55: Distribution of rope damage for a crane with an 8-fall reeving system and multi-layer spooling

Fig. 55 shows the same distribution for a similar crane equipped with a multi-layer drum. Note the rope zone entering the drum is damaged 40 times as much. The consequence is that the most heavily stressed rope zone is no longer in the “slowest” fall but in the “fastest” one and on the rope drum.

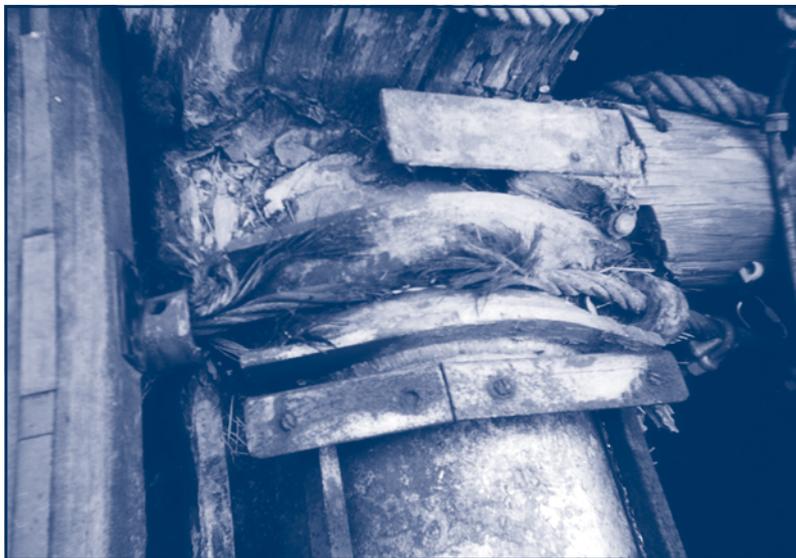
Fig. 57: Severe corrosion and rope failure on the saddle point

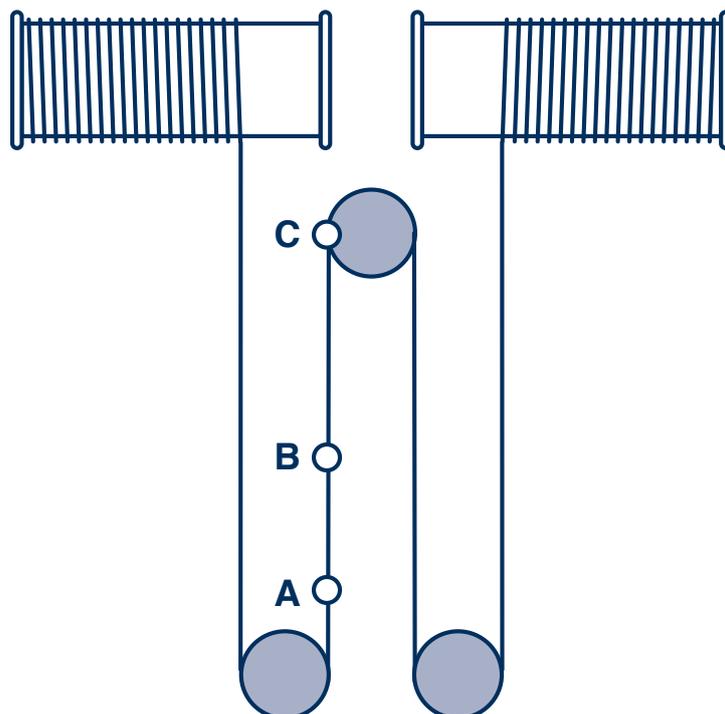
Fig. 58: Overhead crane with twin-drum system and a load compensation sheave

Zone A runs over the lower sheave and onto the drum (i.e. 1 1/2 bending cycles). When the load is lowered Zone A leaves the drum and runs over the lower sheave, thus carrying out 3 bending cycles in total with every lifting procedure.
