R. Verreet

Wire Rope Technology Aachen, Aachen, Germany

Magnetism in rope wires

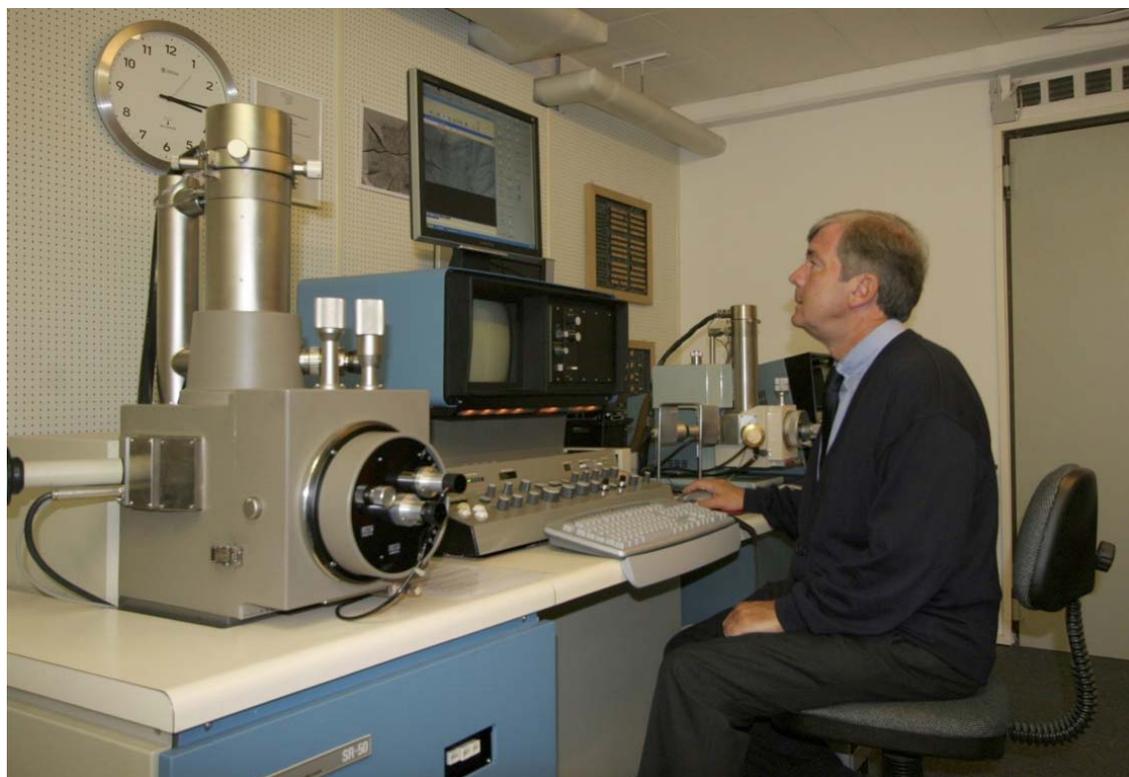
Figure 1: A Scanning Electron Microscope (SEM).

When a wire sample is analysed in a scanning electron microscope (Figure 1) it is put in a vacuum chamber (Figure 2). After evacuating the chamber, a high voltage is applied between a heated cathode and the specimen which acts as an anode. Electrons are then emitted from the cathode and accelerated towards the specimen. A scintillator then detects the secondary electrons emitted from the specimen, and an image of the specimen surface can be created.

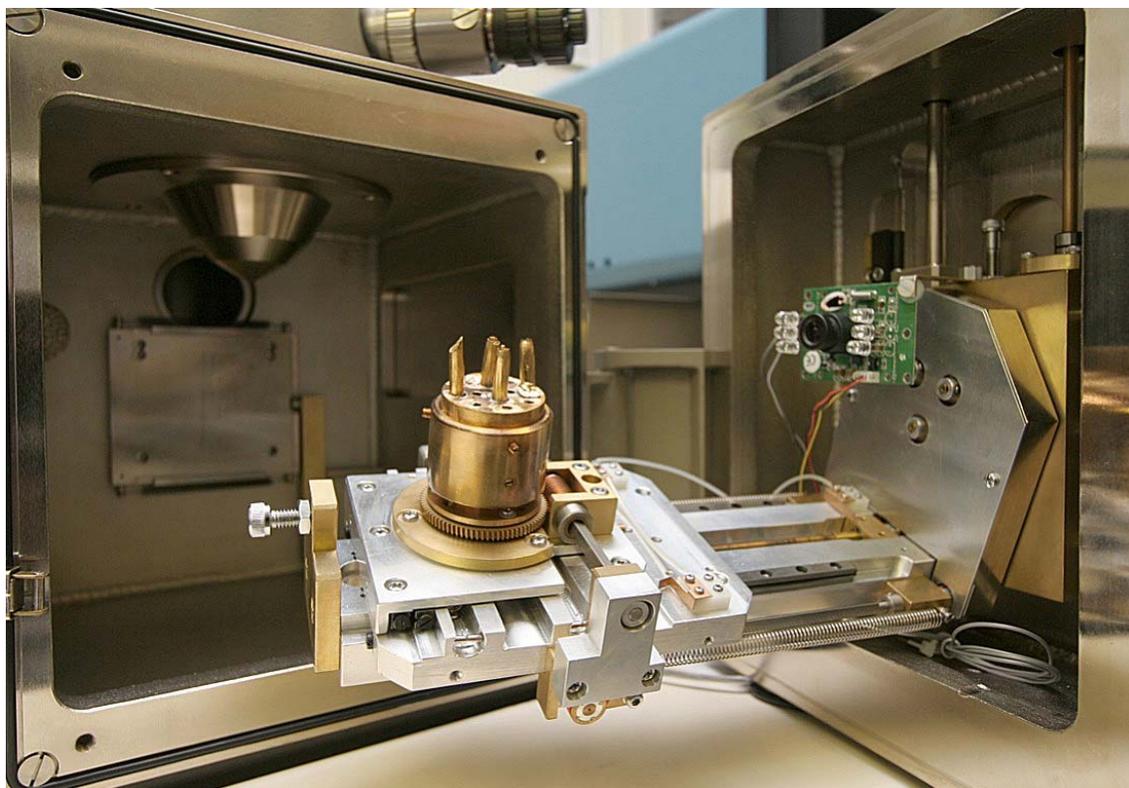
Figure 2: Detail of the vacuum chamber of a scanning electron microscope. (This can be seen closed at the left hand end in Figure 1.)

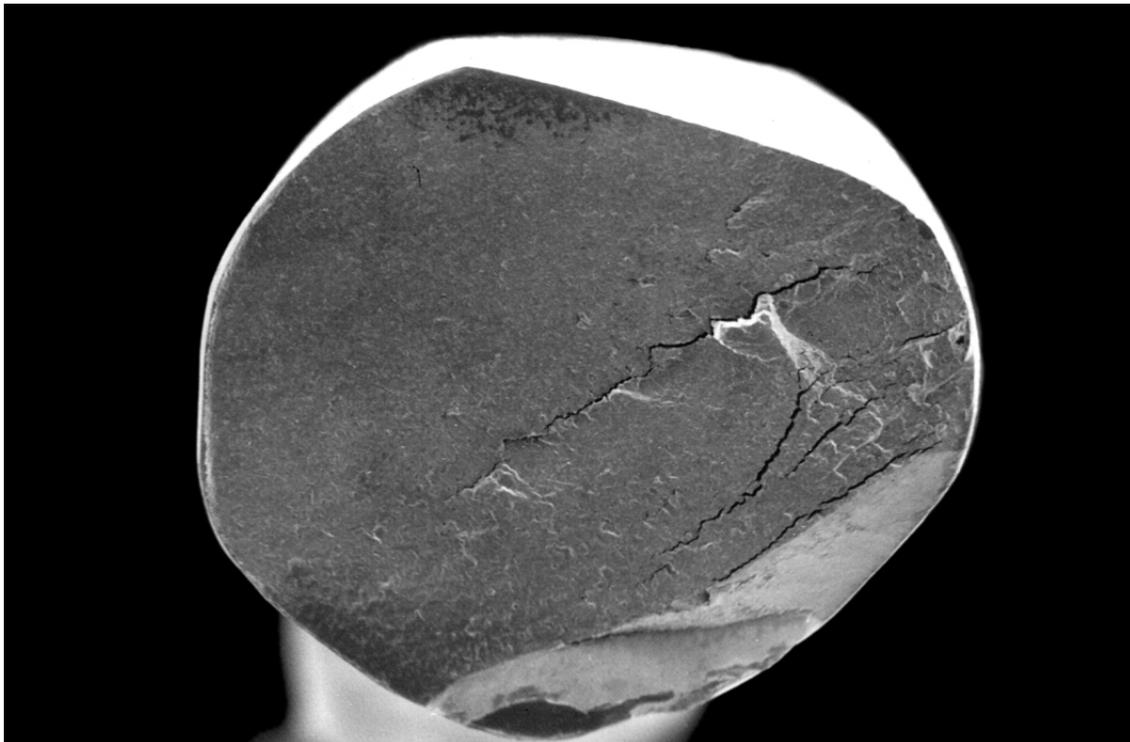
Figure 3: Typical fracture surface of a wire which has failed owing to tension-tension fatigue.

The author has been analysing rope wires in scanning electron microscopes since 1978 [1]. In many cases where a wire had to be demagnetised in order to stabilise the image created by the microscope, the wire break surface later revealed the typical structure of a wire that has fatigued in bending fatigue or tension-tension mode (Figure 3).

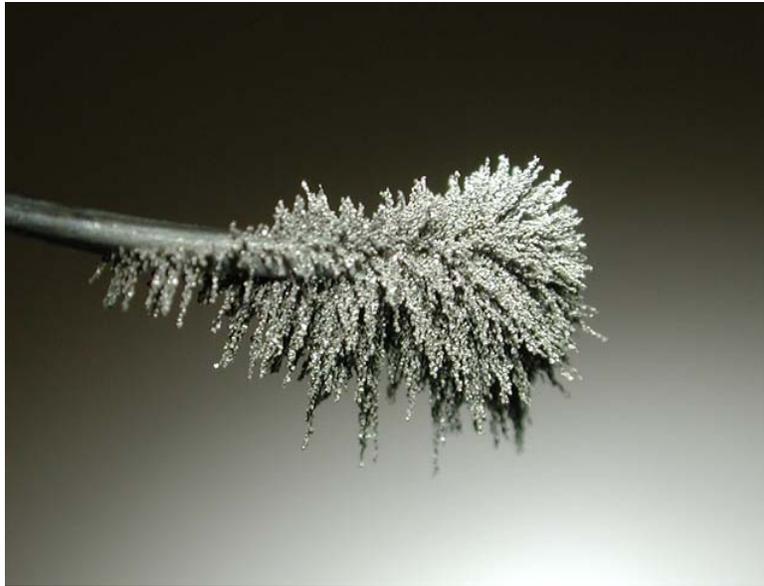
Figure 4: Using iron power to assess the degree of magnetism of a wire.

The author has therefore subjected several steel wire ropes to both bending fatigue and tension-tension fatigue tests. It could be stated that tension-tension fatigue created a high degree of magnetism, and bending fatigue a lesser degree. This could simply be measured by using iron powder (iron filings) which was either attracted by the wire (Figure 4).

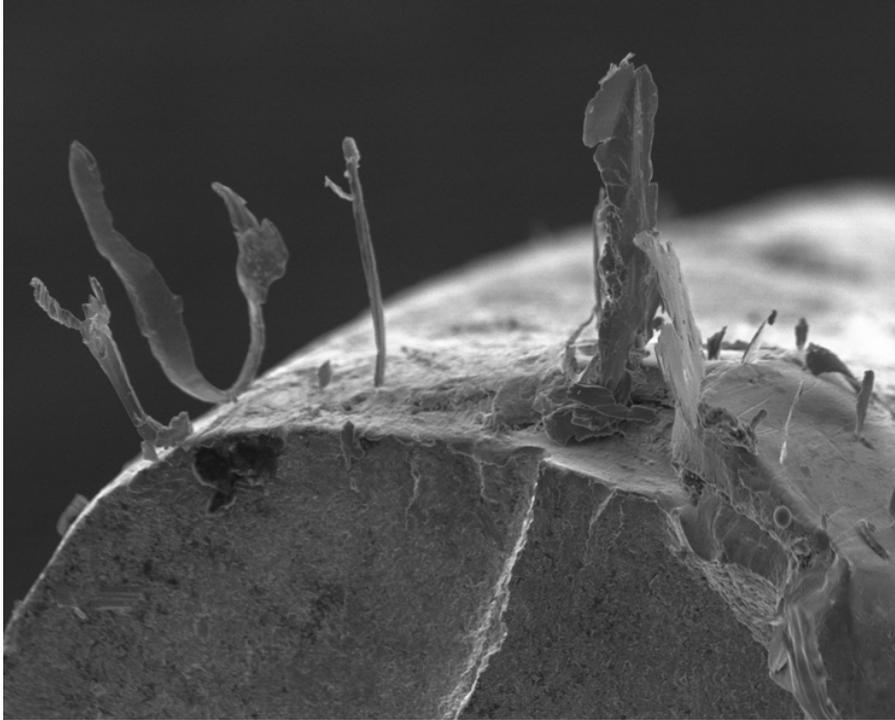
Figure 5: Poor quality SEM image of a wire fracture surface (tension-tension fatigue) owing to magnetism in the wire.

Figure 5 shows a wire from the roller coaster in the original, non demagnetised condition. Because of the disturbance from the magnetic field of the wire the image quality is not too good.
